NATIONAL TRANSPORTATION SAFETY BOARD

HIGHWAY ACCIDENT REPORT

PROPANE TRUCK COLLISION WITH
BRIDGE COLUMN AND FIRE
WHITE PLAINS, NEW YORK
JULY 27, 1994

**Adopted: November 14, 1995
Notation 6479A**

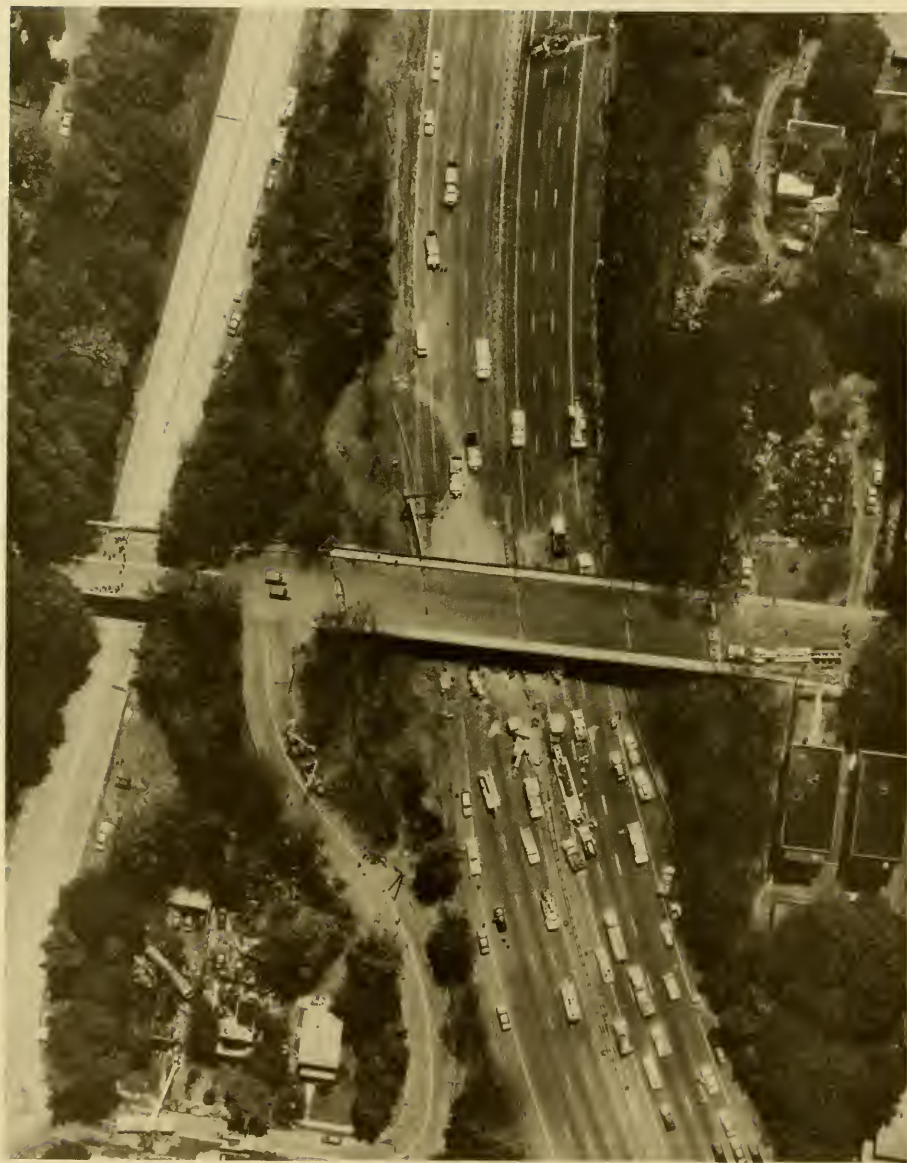
Figure 2. -- Aerial view of accident site (Photo by Chas. H. Sells, Inc.)

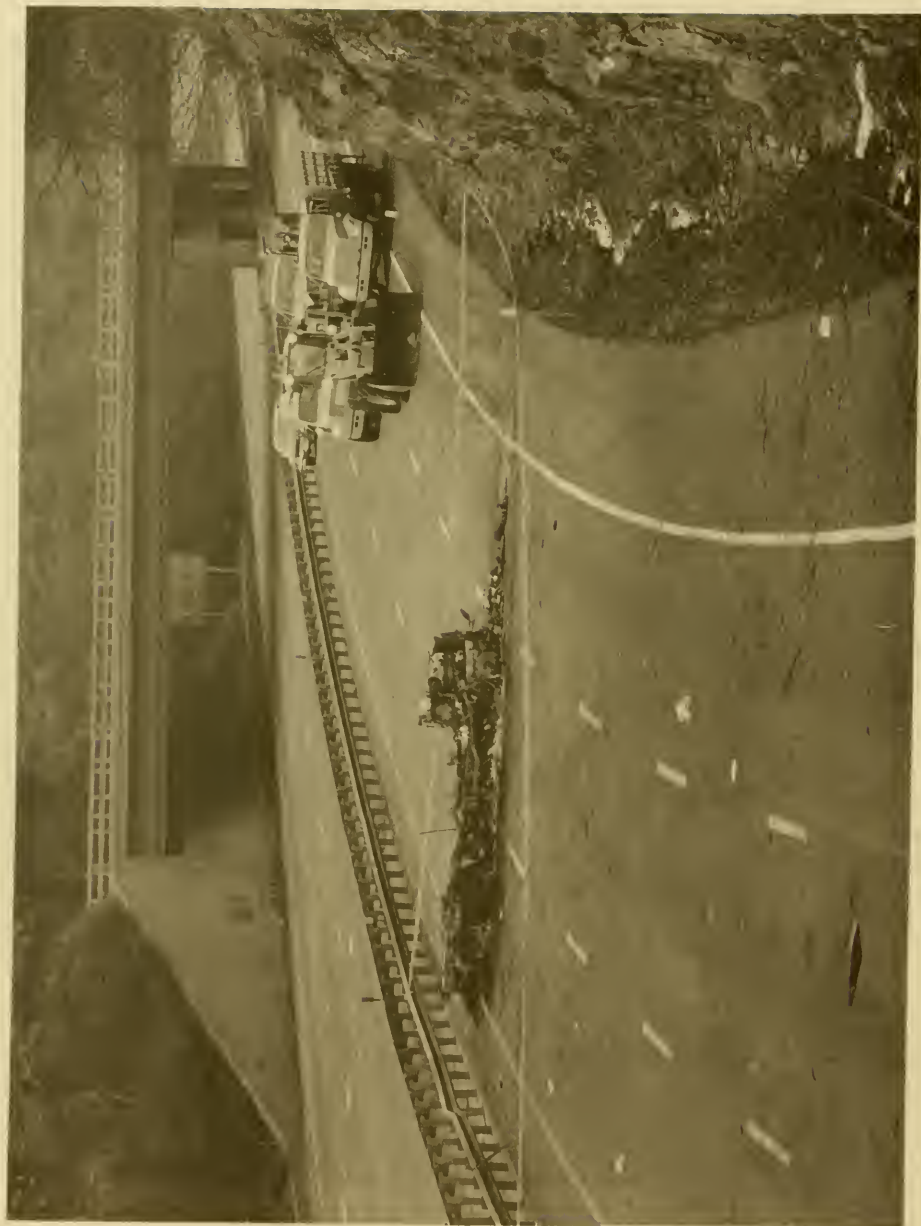
Vehicle Damage -- The tractor body and tires were destroyed by fire. The tractor above the frame rail burned, except for the engine, radiator, fire wall, and fifth wheel. Of the remaining components, only the left side of the front bumper was deformed in a way that could have resulted from a collision. The radiator showed no signs of having been in a collision. (See figures 3 and 4.)

Figure 3. -- Final rest position of tractor on I-287 (Photo by Mike Horn)

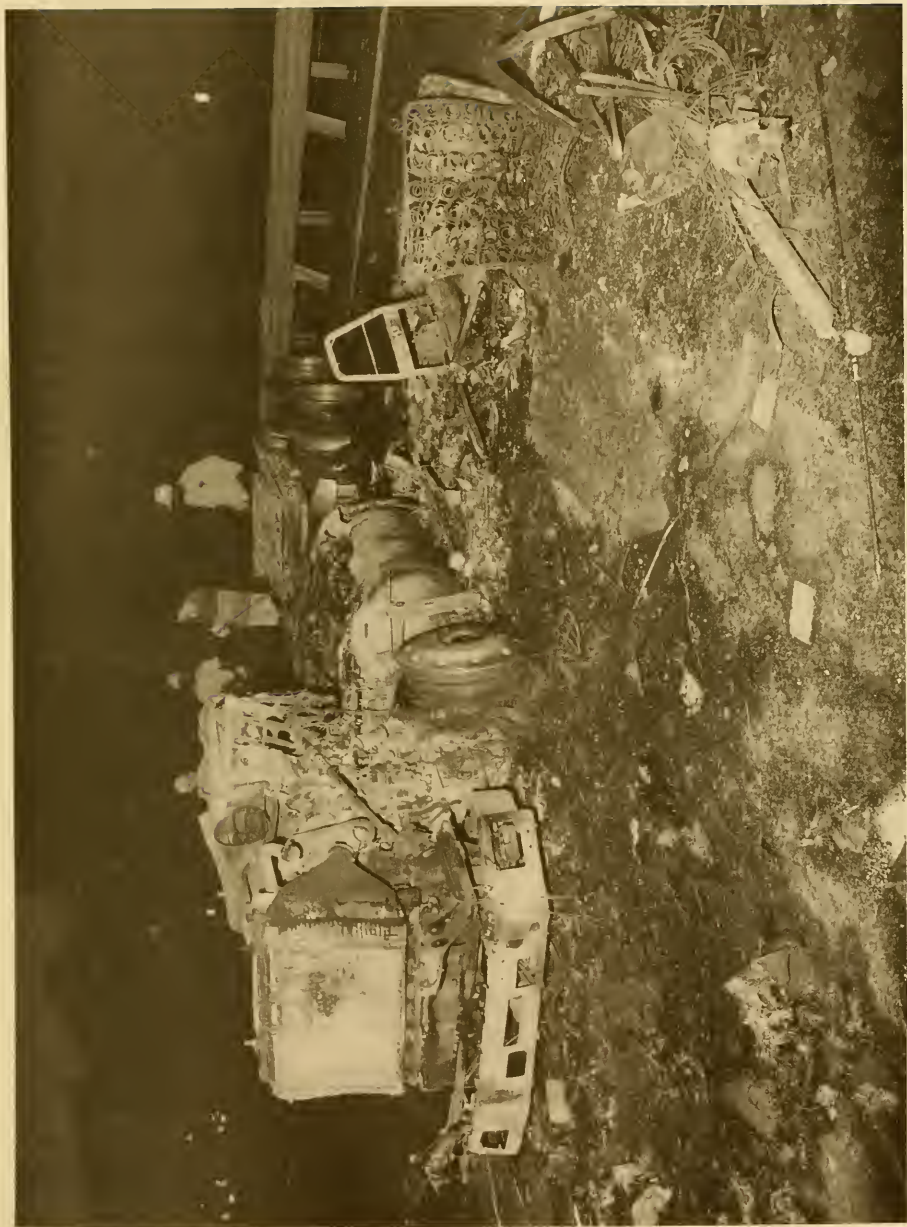
Figure 4. -- Close-up of front of tractor (Photo by Mike Horn)

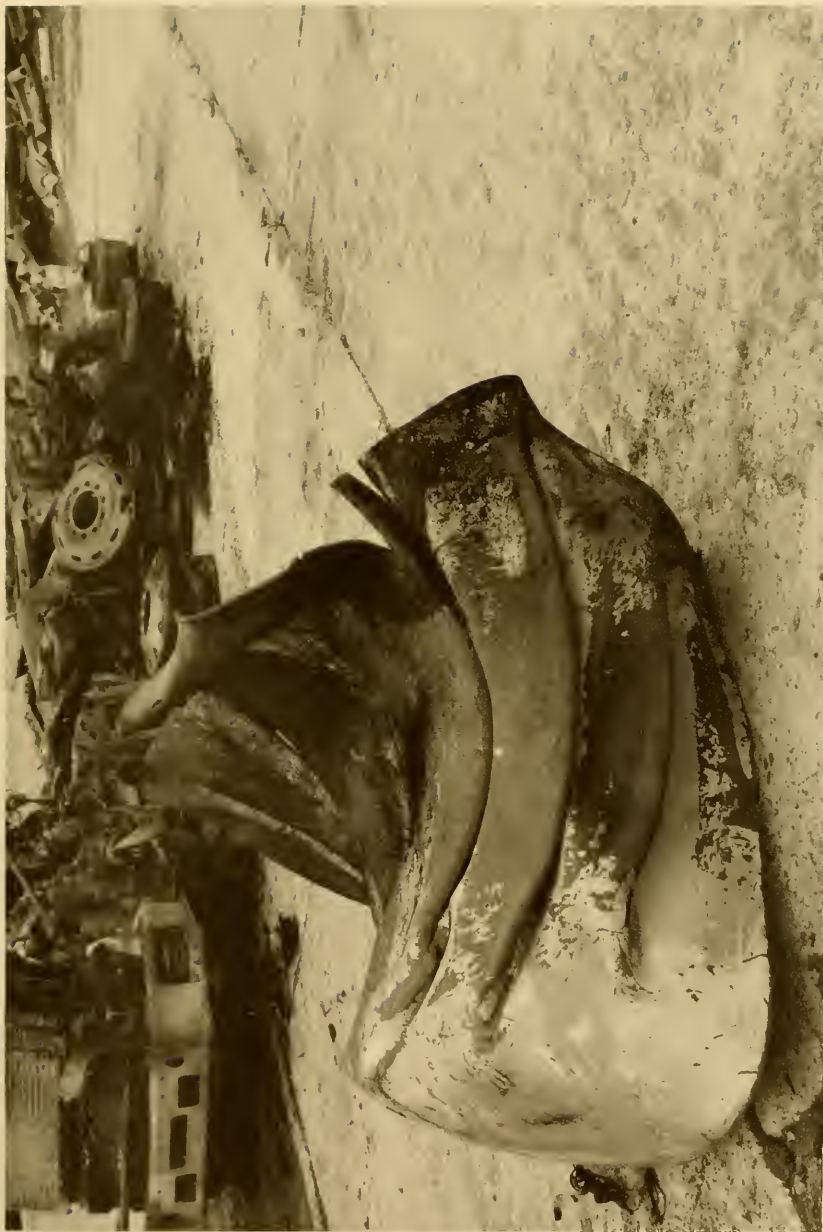
The exterior of the tank was scorched, except for an area at the lower rear and for the rear manhole cover. A portion of the head was found separated from the tank. The head contained a large cylindrical indentation that was oriented in a horizontal direction (consistent with impact at a 90-degree angle during a vehicle rollover). (See figure 5.) The size of the indentation was consistent with the diameter of the vertical columns of the Grant Avenue overpass. The landing gear, the two-axle assemblies, and the underbody plumbing of the semitrailer were torn away.

Figure 5. -- Front head of cargo tank

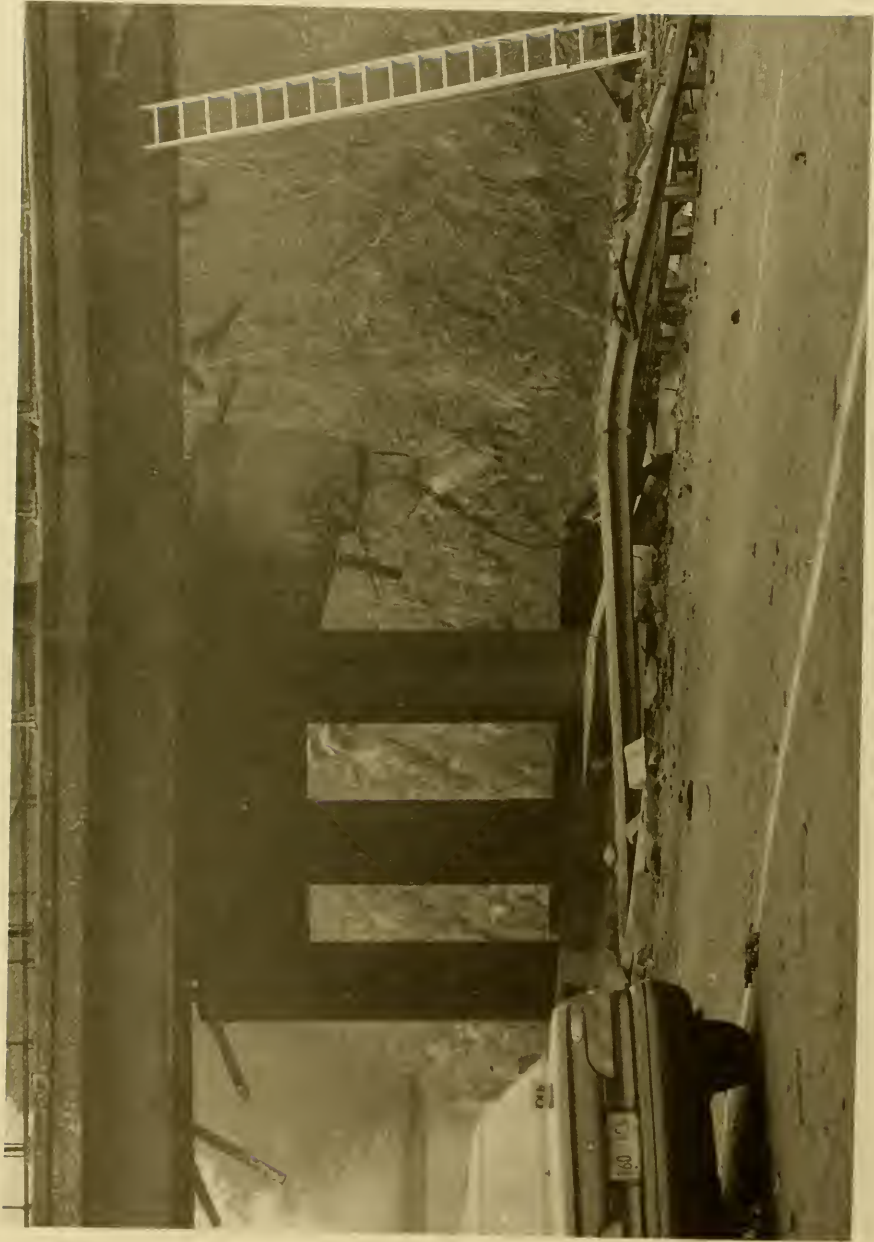
Highway and Bridge Damage -- Both the eastbound and westbound median guardrail on the eastbound approach to the bridge was destroyed. The pavement was scorched in several places. The west bridge column was sheared off at the point of impact, causing that portion of the pier cap beam and stringers to sag. (See figure 6.) After the accident, the superstructure was temporarily supported with six steel columns that could take the load should the cap beam sag further. The two interior spans of the southbound spans were later removed. As of November 14, 1995, the bridge was open to a single lane of traffic on Grant Avenue. The cost of cleaning up and temporarily repairing the bridge was \$254,000, and the New York State Department of Transportation (NYSDOT) estimated that it would cost \$213,000 to repair the bridge and median barrier permanently.

Figure 6. -- Damaged column of Grant Avenue overpass (Photo by Mike Horn)

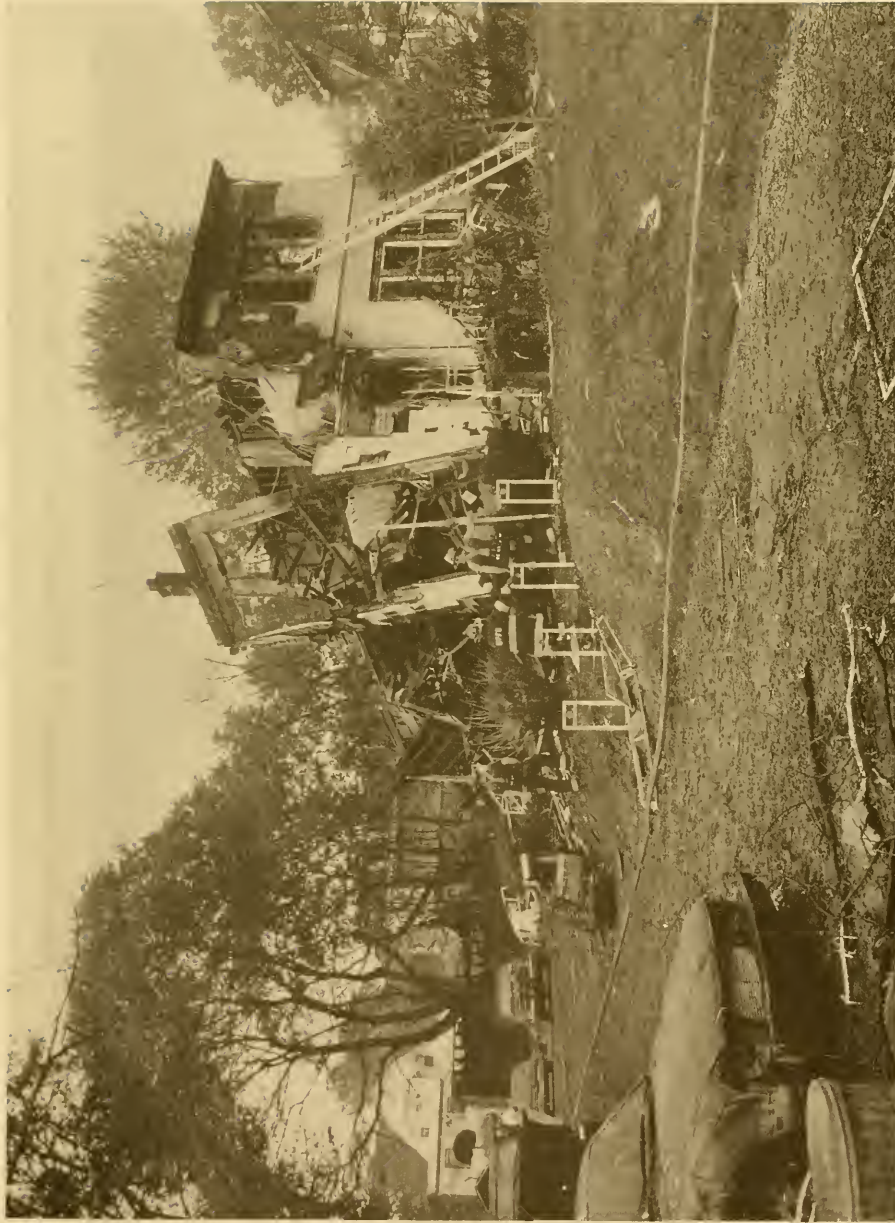
Figure 7. -- Fire damage at 77-81 Grant Avenue (Photo by Mike Horn)

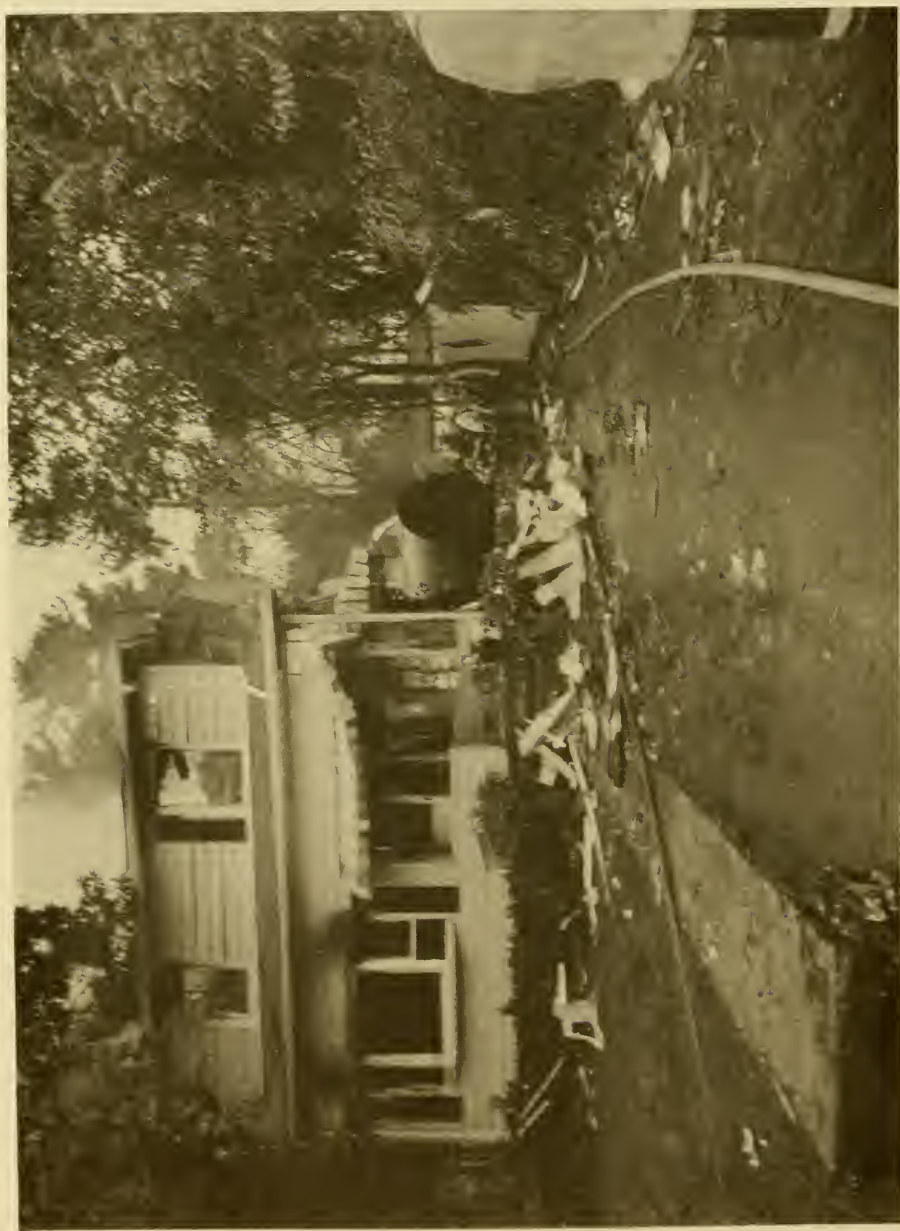
Figure 8. -- Fire damage of 103 Clinton Street (Photo by Mike Horn)

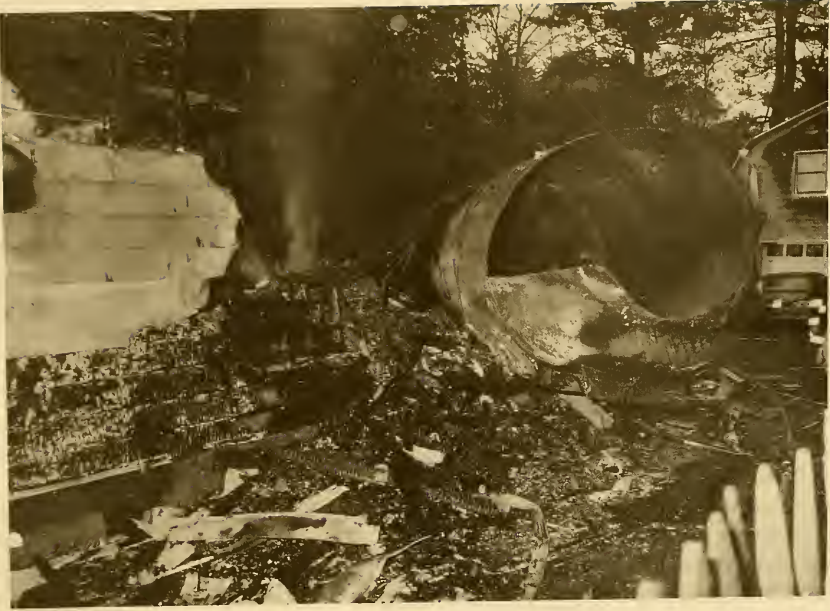
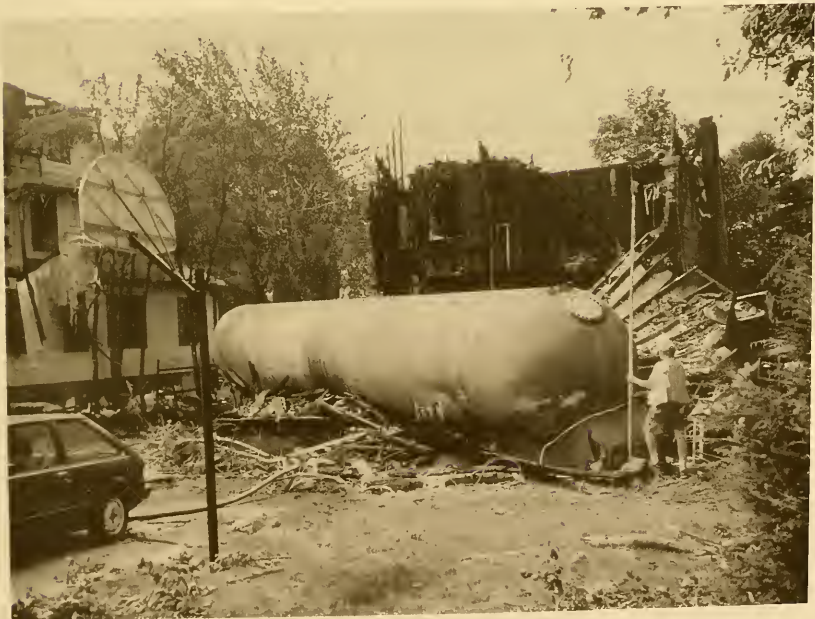
Tank -- The amount of crush in the front head was about 21 inches. The separation was between the 9 and 2 o'clock position, looking aft (where the 12 o'clock position is defined as the top of the cylinder) along the heat-affected zone of the weld. The fracture then left the circumferential path and extended forward in the cylinder head and returned to the 9 o'clock position. (See figure 9.)

Figure 9. – Front and rear views of tank at rest at 103 Clinton Street
(top photo by Mike Horn; bottom photo by Chas. H. Sells, Inc.)

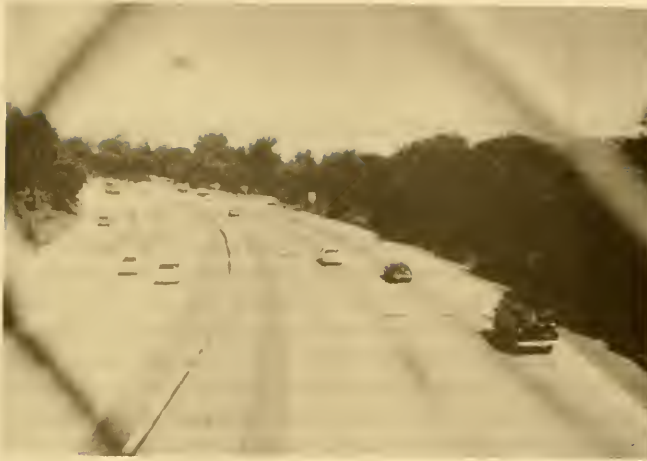
A -- Looking west from Grant Avenue overpass at box beam guardrail

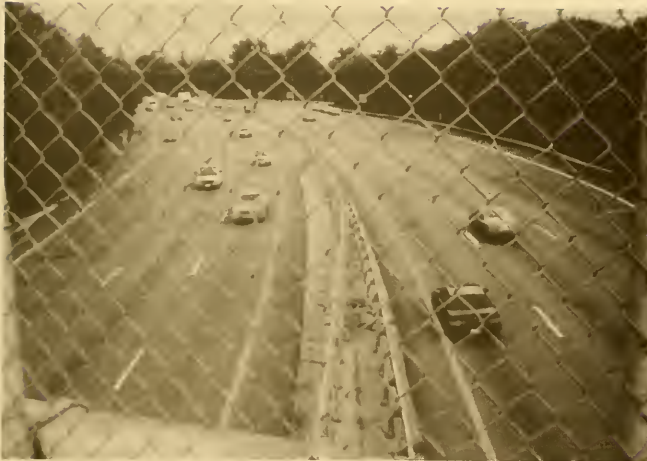
B -- Looking west from Grant Avenue overpass at strong post block-out guardrail

The blocked-out W-beam (strong post) barrier system in place at the time of the accident was a standard design that had been used by the NYSDOT since 1979. After the accident, the guardrail was replaced with another guardrail of the same design. This system is the most common barrier system in use today, but it was designed primarily to protect passenger cars by redirecting them from roadside obstacles. It is classified as an operational semi-rigid system by the AASHTO *Roadside Design Guide*, which means that it has demonstrated satisfactory field performance in terms of construction and has been successfully crash tested for automobiles.³⁴ In crash tests, this barrier was marginally successful in redirecting two pickup trucks weighing 3,260 and 4,179 pounds, respectively.

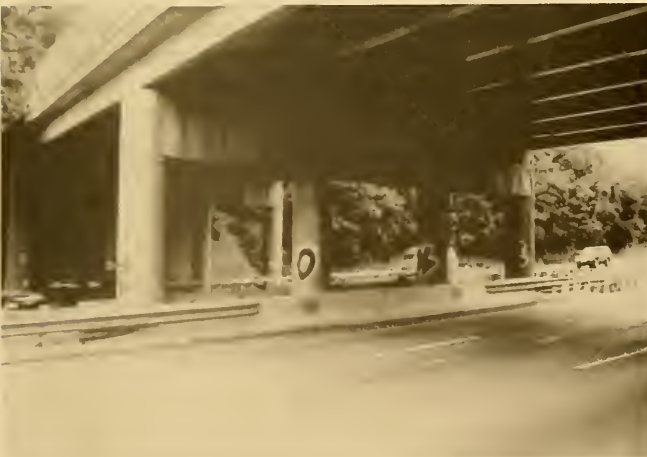
C -- Attachment of W-beam guardrail to concrete barrier

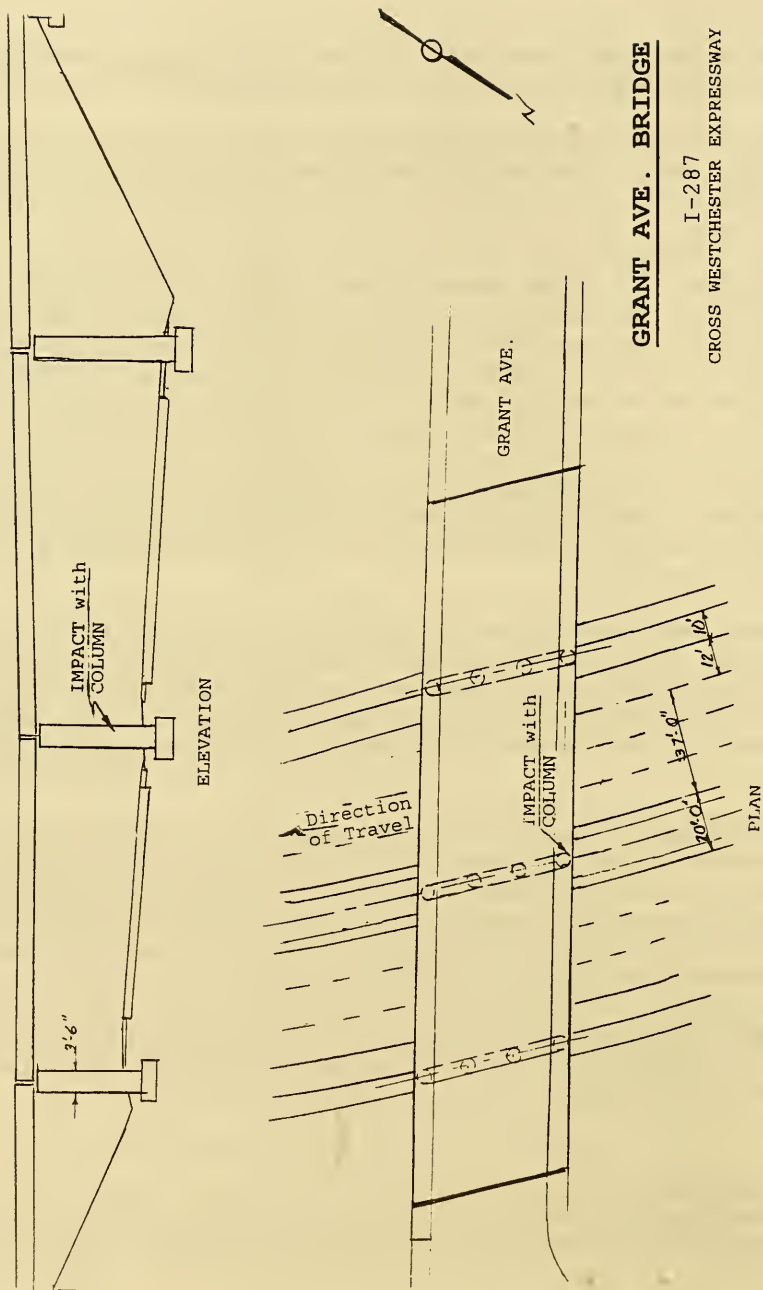
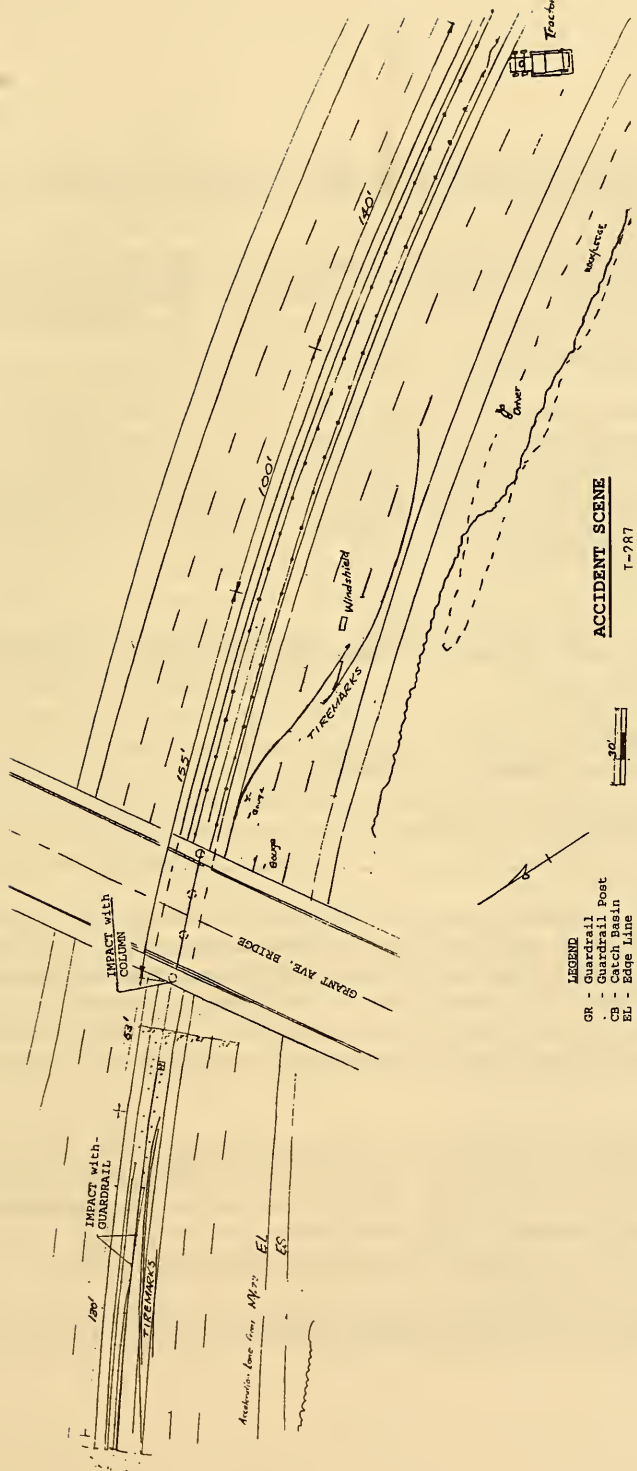
Figure 14.--Accident scene

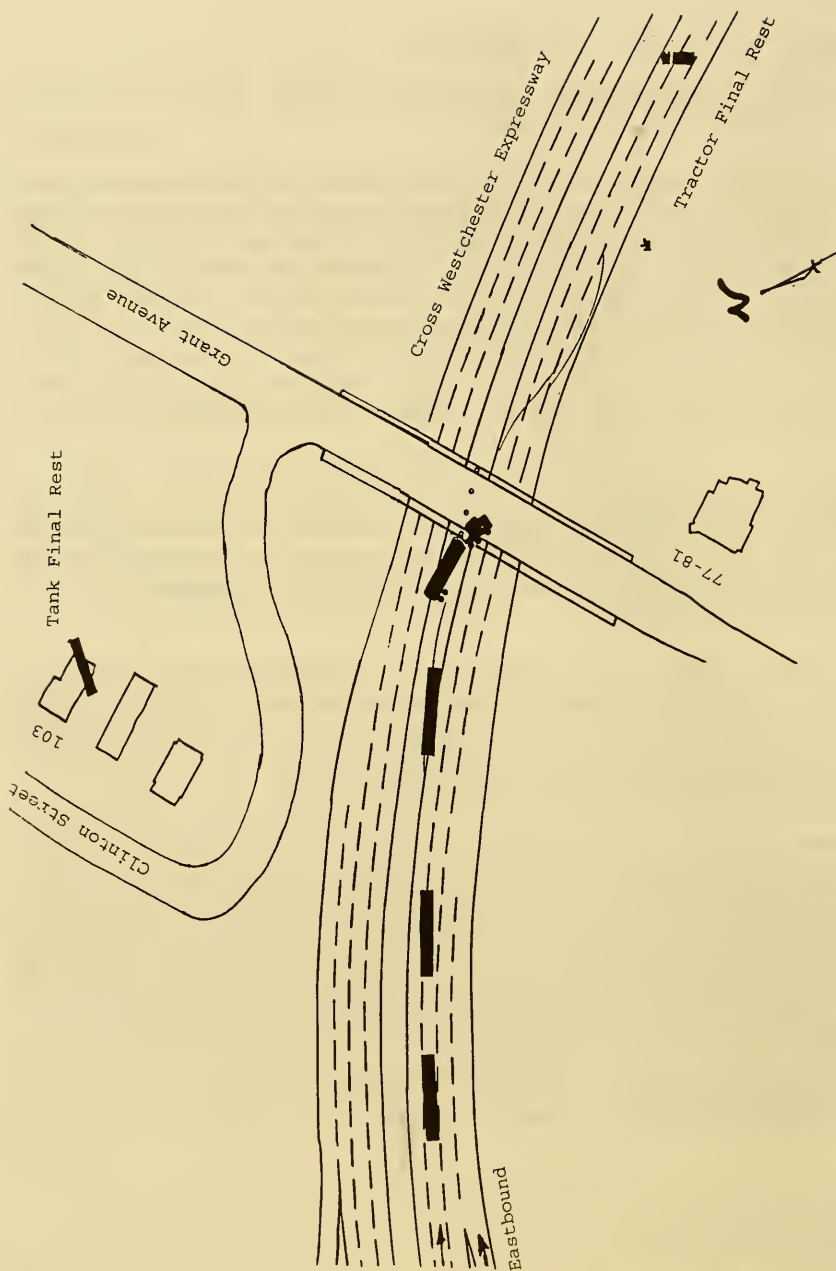
In the collision, the tank sheared the bridge column off. The force of the impact caused a catastrophic failure of the tank.

Figure 15. -- Rollover sequence
